National Register of Historic Places Inventory—Nomination Form

historic Benson Block

and or common Potter Block

street & number 108-12 N. Market ___ not for publication

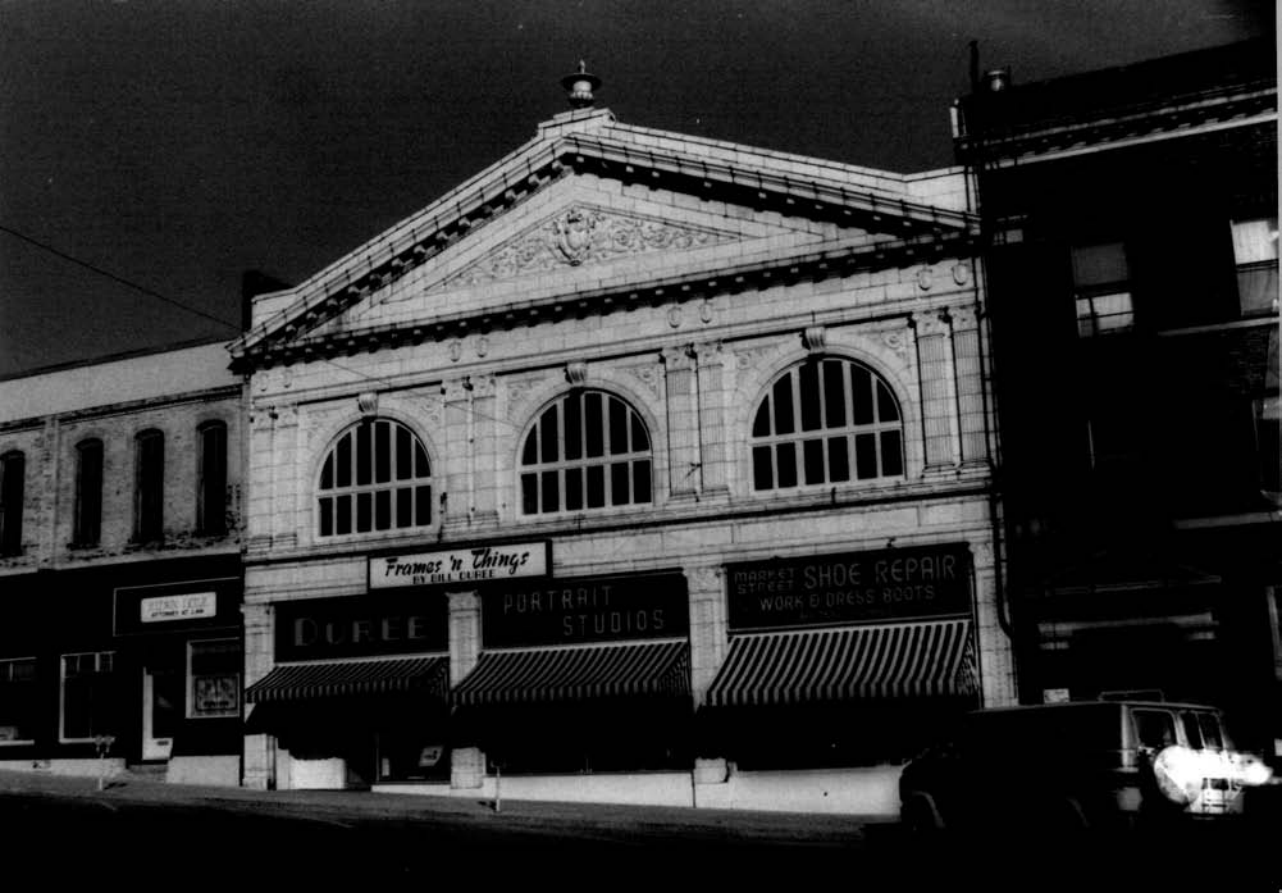
The terra cotta facade executed in the neo-classical style is the dominant significant feature of the Benson building. Originally designed as a theater, the symmetrical design allowed for a three entrance bays, now broken into three storefronts. Ornate pilasters with engaged Corinthian capitals separate each bay on the first floor. Clerestory spaces above each bay are presently filled with signage, but probably originally were glassed in some manner, with higher interior ceilings. String courses, a panel band, and projecting sill, composed of relatively small terra cotta pieces set in a dark mortar, separate the two floor levels. Three large arched windows with casement window infill are on the second floor separated by paired fluted pilasters with Corinthian capitals. Projecting scrolled keystones project above each window. The neo-classical style is represented by pilasters, columns, detailing, and the pedimented gable which covers the front parapet wall. The broadly projecting gable is dentillated. A triangular frieze features an elaborate cartouche and rinceau. A parapet wall tops the pediment and is in turn capped with a free standing statuary urn at its peak.

of the building produced these fronts, and that what became the Benson building was damaged in 1923 so as to require rebuilding. The use after 1916 of the subject building for auto retailing strongly hints at minimally some first floor remodeling. The present front dates from late 1924. The interior freight elevator was relocated to the present site, towards the southeast corner, and rear windows were located on the first and second floors, three per floor. The only noticeable deterioration on the facade is the disintegration of several of the terra cotta dentils on the pediment front. The present signage obstructs the original clerestory openings.
